GEOTECHNICAL ENGINEERING
SERVICES REPORT

EAST CENTRAL UNIVERSITY (ECU) SLOPE FAILURE
PROPOSED RETAINING WALL
SOUTHWEST OF THE INTERSECTION OF
S. STADIUM DRIVE AND E. 10TH STREET
ADA, OKLAHOMA

EST PROJECT NUMBER
6010092

May 19, 2020

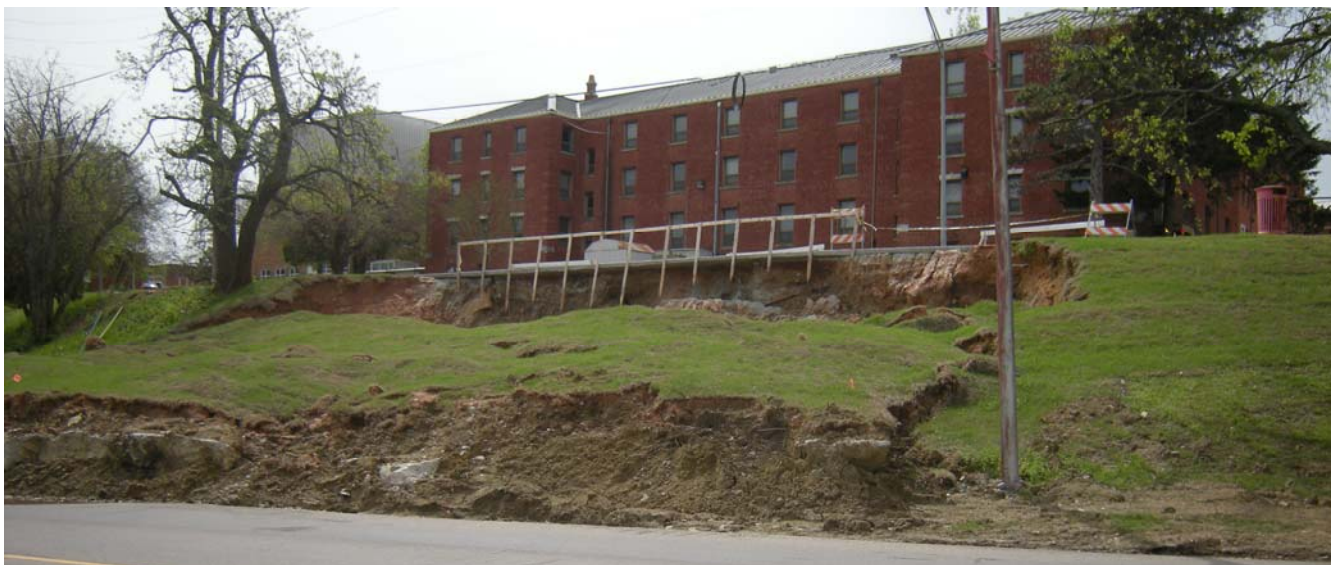
Photograph #1: ECU Slope Failure

Based on the observed water level readings, boring location B-1 (north side of failure) does not have any groundwater. At boring location B-2, the groundwater level in the boring rose from 11.5 feet to 2.5 feet below the existing ground surface. This indicates that groundwater is flowing into this area, which is evident by the persistent failure of the slope.

We understand the proposed retaining wall is expected to be constructed approximately 12 feet from the existing sidewalk, and will be used to step down and flatten the slope leading to the roadway (S. Stadium Drive), the drainage system behind the wall will be used to redirect the persistent groundwater around the slope failure area.

Because of the existing problem with groundwater infiltration, to help prevent hydrostatic loading on the walls, a perforated, rigid plastic or metal drain line should be installed at the base of the walls. The drain line should be sloped to provide positive gravity drainage to a suitable collection point. To prevent the intrusion of fines into the drain system, the drain line should be surrounded by at least 6 inches of clean, well-graded crushed aggregate encapsulated with a suitable filter fabric. A class 2 non-woven geotextile with a maximum apparent opening size (AOS) of 0.25 should be used. Free draining granular fill should be used to backfill above the drains and should extend behind the walls a minimum width of 24 inches. The upper 2 feet of backfill placed adjacent to the walls should consist of an approved, compacted, low volume change cohesive soil to reduce surface water infiltration. A procedure should be used to discharge water from the outlet point, which would not allow reverse flow into the drain system.

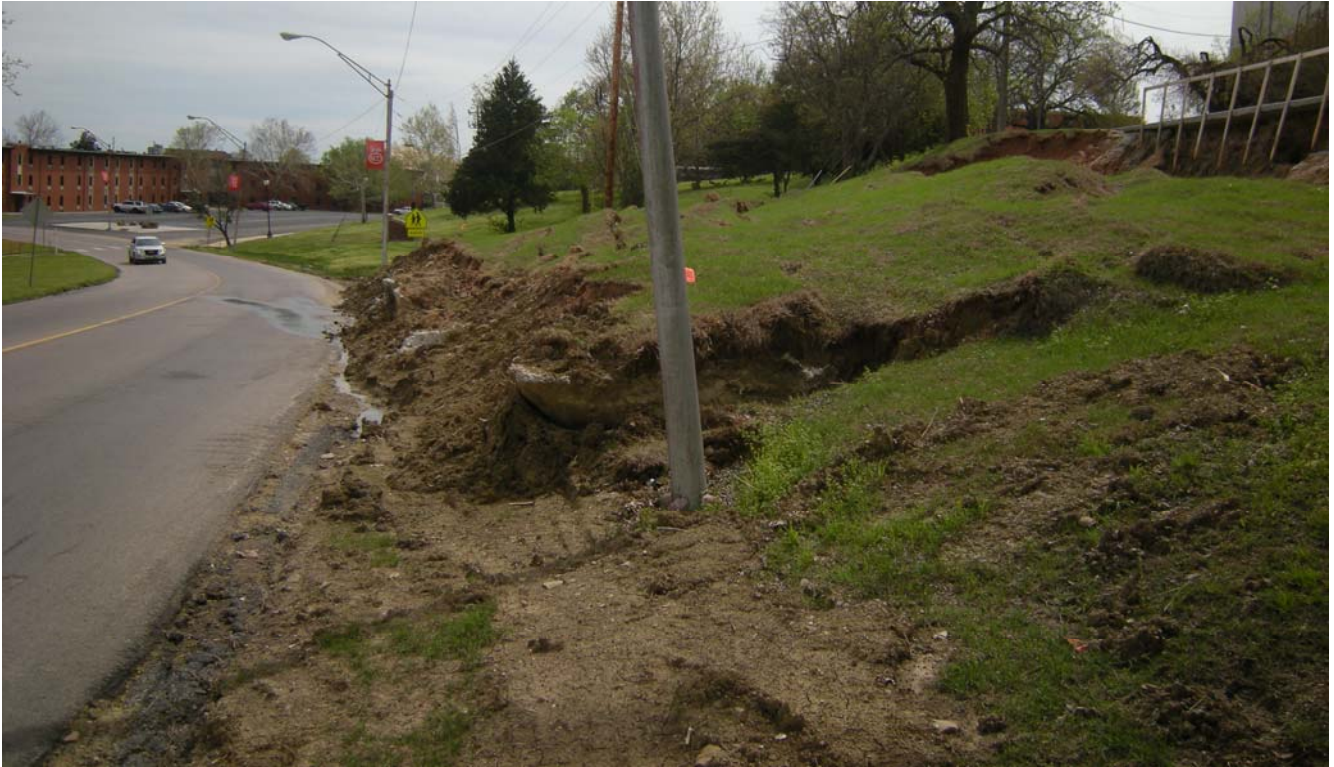
Photograph #2: ECU Slope Failure

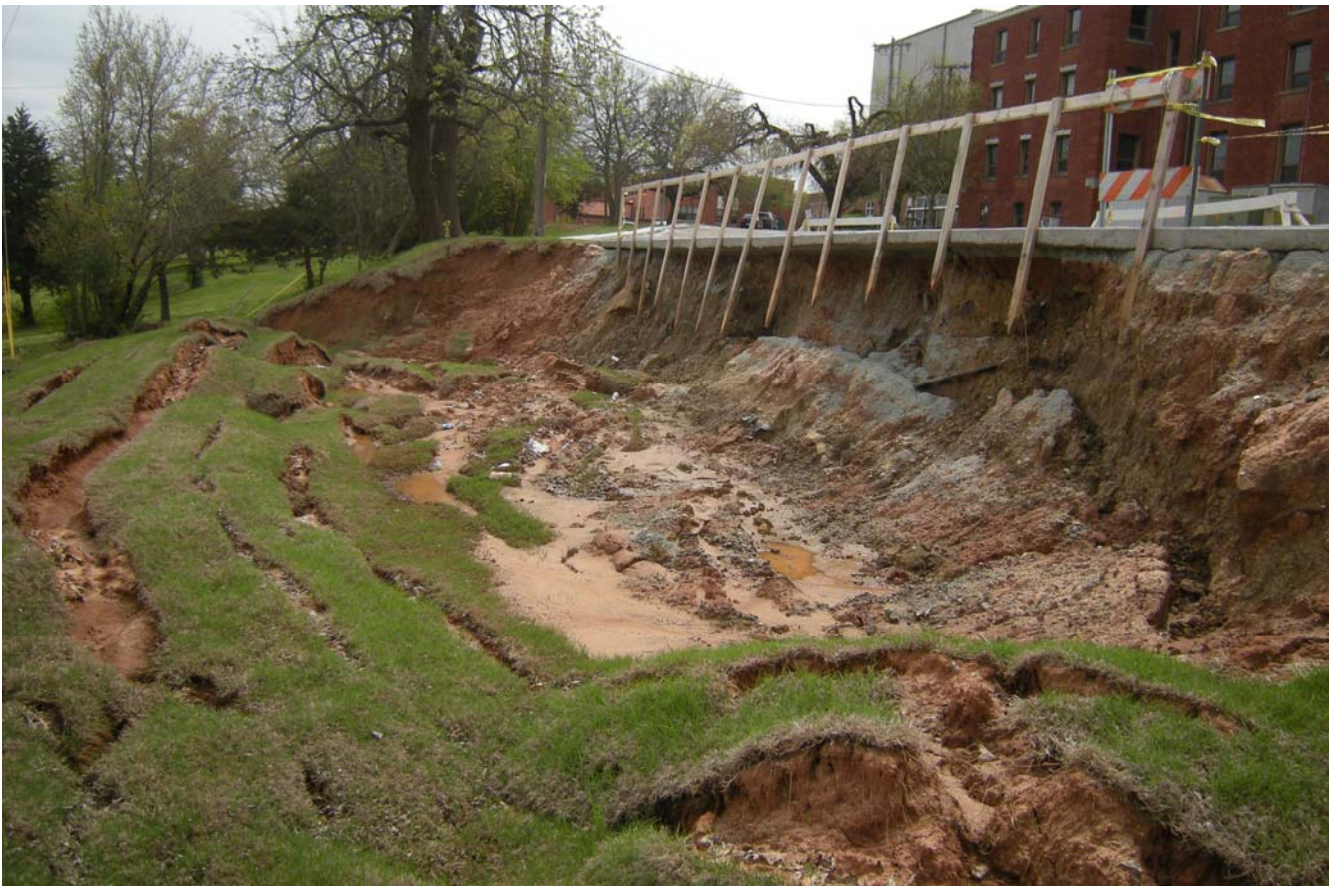
Photograph #3: ECU Slope Failure
