GEOTECHNICAL ENGINEERING
SERVICES REPORT

EAST CENTRAL UNIVERSITY (ECU) SLOPE FAILURE
PROPOSED RETAINING WALL
SOUTHWEST OF THE INTERSECTION OF
S. STADIUM DRIVE AND E. 10TH STREET
ADA, OKLAHOMA

EST PROJECT NUMBER
6010092

May 19, 2020

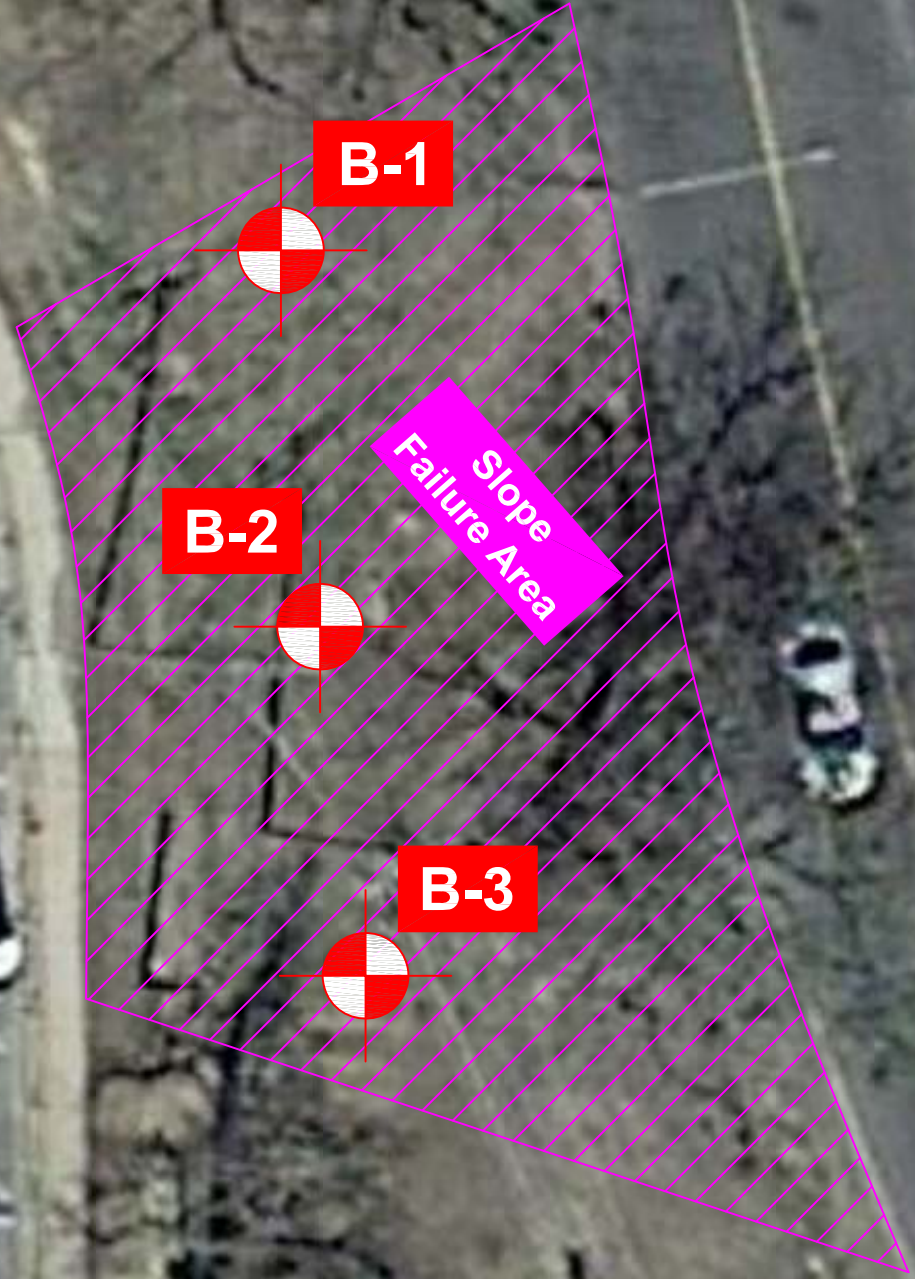
**Elevations Benchmark
TBM #1: Chiseled Square
Elevation = 1025.91 feet**

Boring Surface Elevations:
B-1: 1015.9'
B-2: 1016.5'
B-3: 1015.2'
